REPORT NO. 3617  
UNION PACIFIC RAILROAD COMPANY  
IN RE ACCIDENT  
AT SOUTH MONTESANO, WASH., ON  
MARCH 15, 1955

Kind of accident: Rear-end collision

Accident at South Montesano, Wash., on March 15, 1955,  
caused by failure properly to control the speed  
of the following train moving within yard limits.

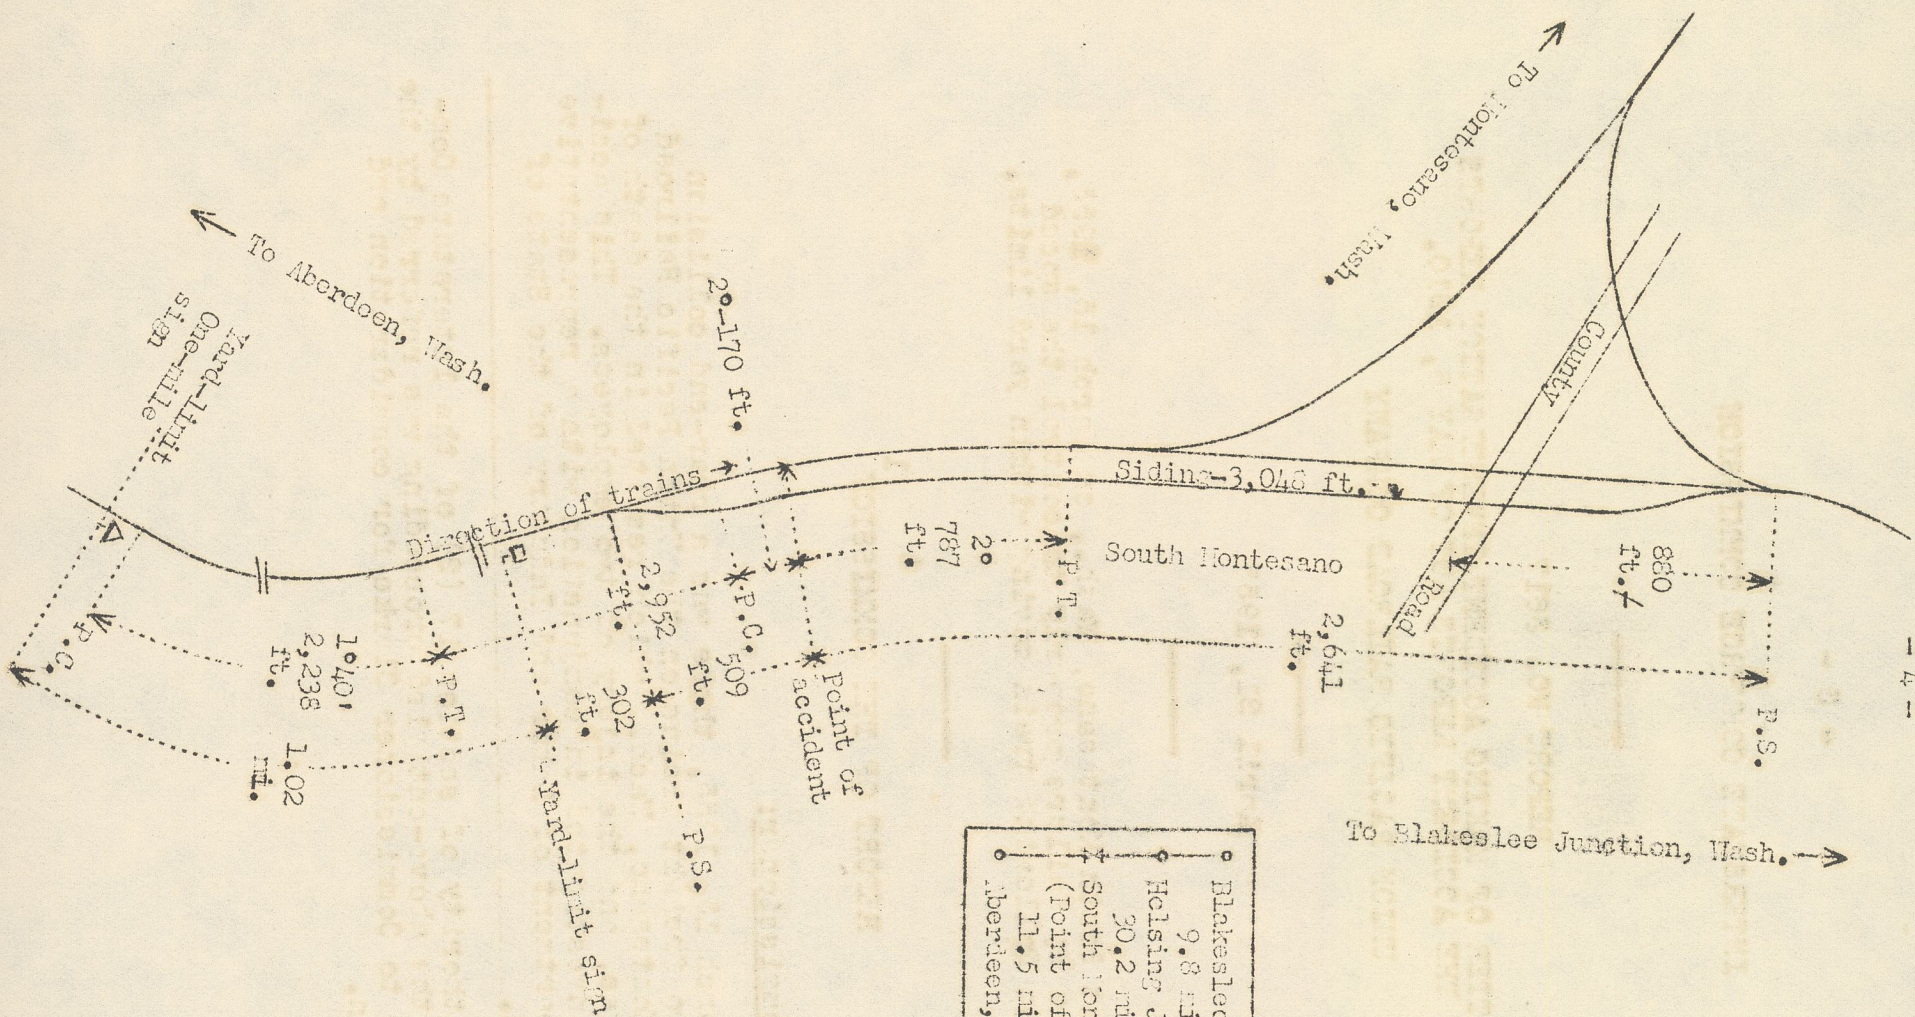
Report No. 3617  
 Union Pacific Railroad  
 South Montesano, Wash.  
 March 15, 1955

Location of Accident and Method of Operation

This accident occurred on that part of the Oregon Division extending between Aberdeen and Blakeslee Junction, Wash., 51.5 miles. In the vicinity of the point of accident this is a single-track line, over which trains are operated by timetable and train orders. There is no block system in use. Trains of the Chicago, Milwaukee, St. Paul and Pacific Railroad regularly are operated over the portion of the Union Pacific extending between Aberdeen and Helsing Junction, 41.7 miles east of Aberdeen. At South Montesano, 11.5 miles east of Aberdeen, a siding 3,048 feet in length parallels the main track on the south. The west switch of this siding is 302 feet east of the west yard-limit sign. The accident occurred on the main track within yard limits at a point 811 feet east of the west yard-limit sign and 509 feet east of the west siding-switch. Within yard limits at South Montesano a wye connects the main track with a line 1.5 miles in length which extends northward to Montesano. The east switch of the wye is located in the main track 2,641 feet east of the point of accident. From the west there are, in succession, a 1°40' curve to the left 2,238 feet in length, a tangent 2,952 feet, and a 2° curve to the right 170 feet to the point of accident and 787 feet eastward. The grade for east-bound trains varies between level and 0.35 percent descending throughout a distance of 3,100 feet immediately west of the point of accident, and it is 0.23 percent descending at that point.
